**CONSENT ORDER
ISSUED UNDER THE
WATER POLLUTION CONTROL ACT
WEST VIRGINIA CODE, CHAPTER 22, ARTICLE 11**

TO: MarkWest Liberty Midstream & Resources, L.L.C. DATE: March 28, 2019
Gregory Bezdek, SVP, NE Region
4600 J Barry Ct. Ste 500
Canonsburg, PA 15317 ORDER NO.: 8945

MARKWEST LIBERTY MIDSTREAM & RESOURCES, L.L.C, WVR311004, Sherwood to Mobley
20" NGL, 8/22 & 8/23/2018

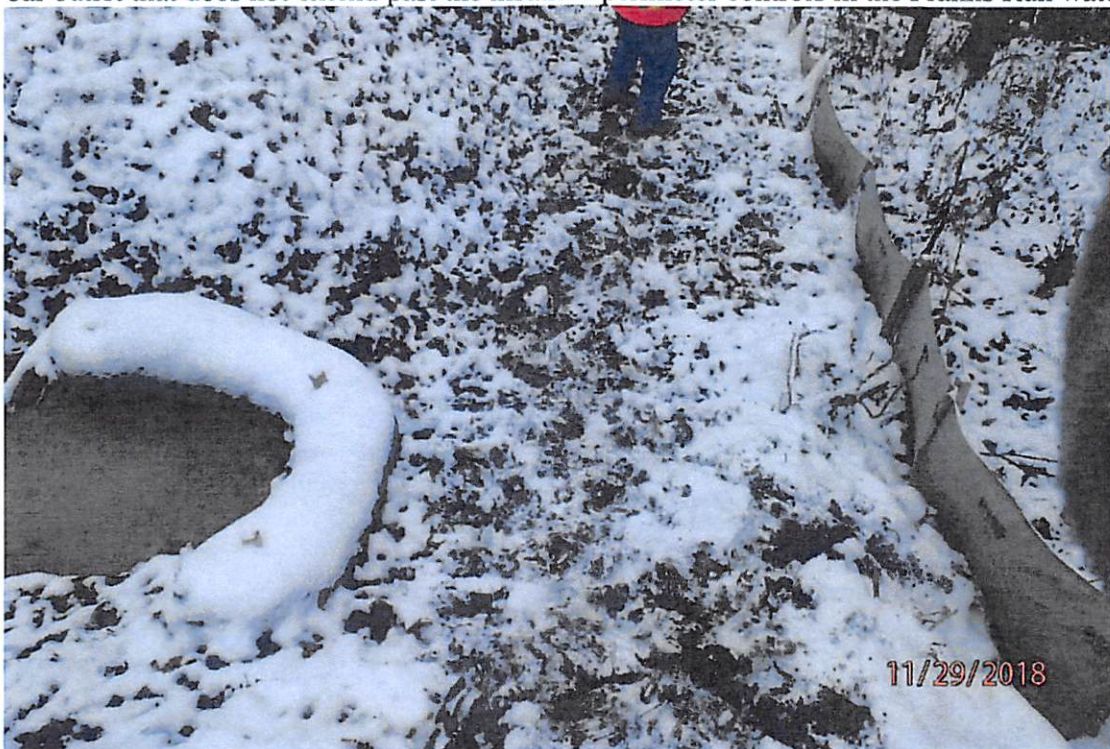
Water bar outlet that does not extend past the installed perimeter controls in the Beverlin Fork watershed.

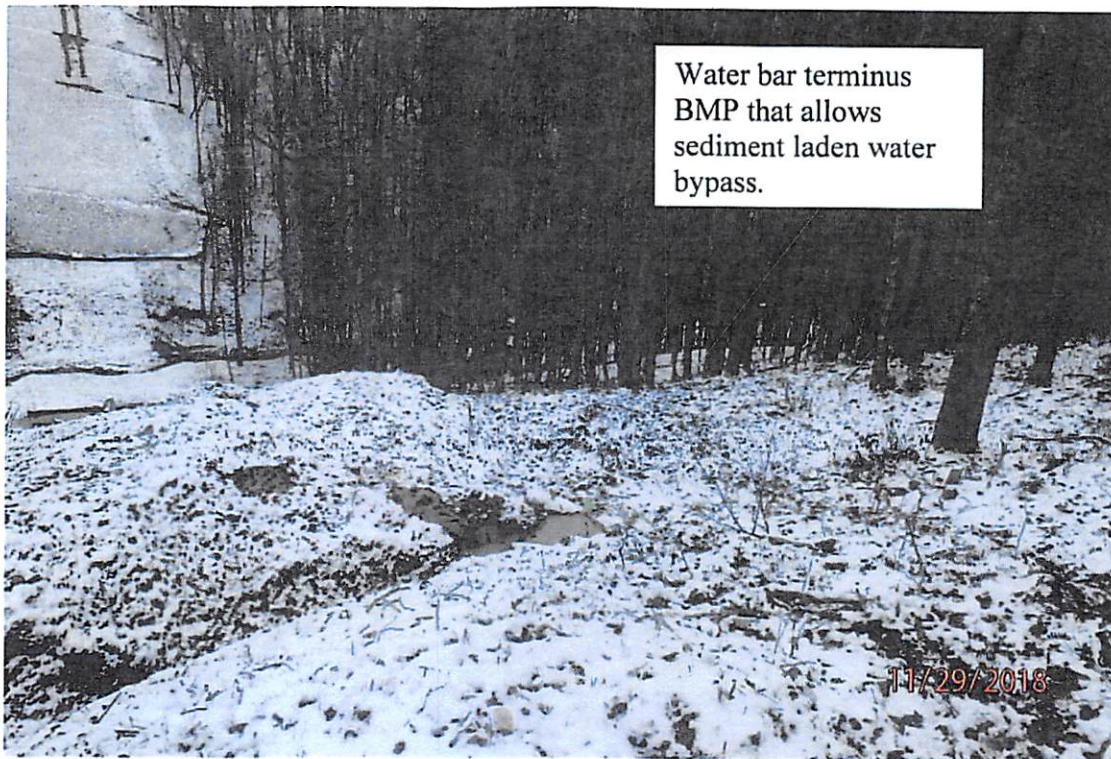
Water bar terminus BMP that allows sediment laden water bypass near 861+00.

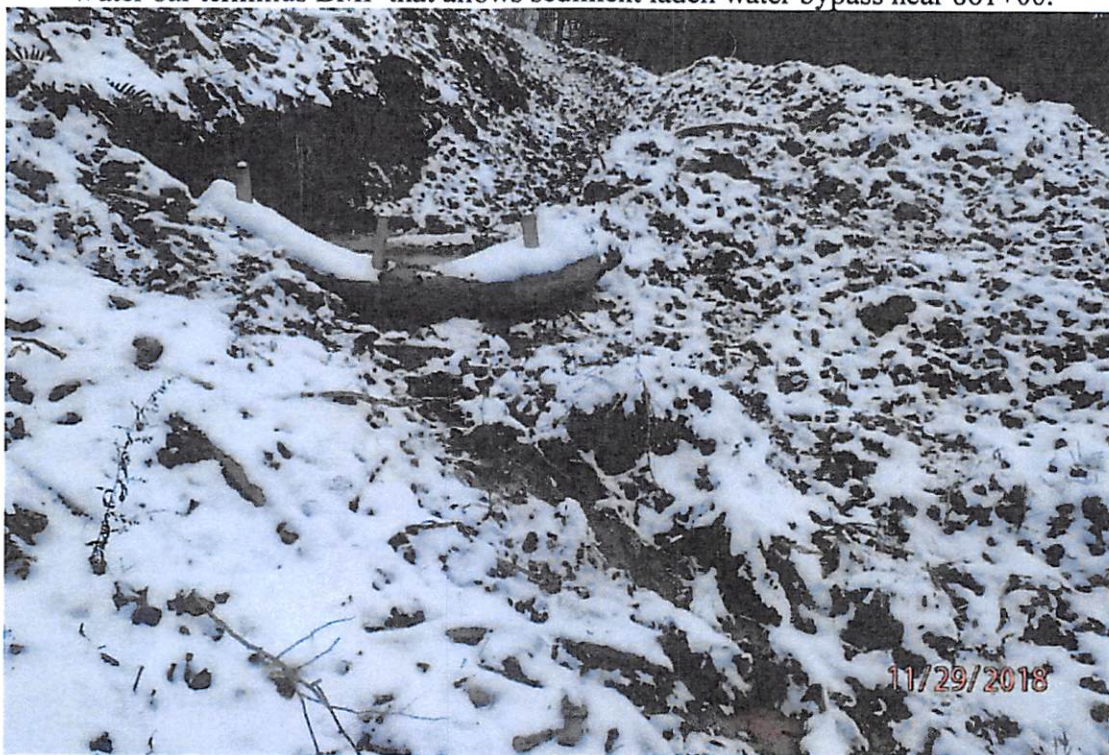
Water bar terminus BMP that allows sediment laden water bypass near 861+00.

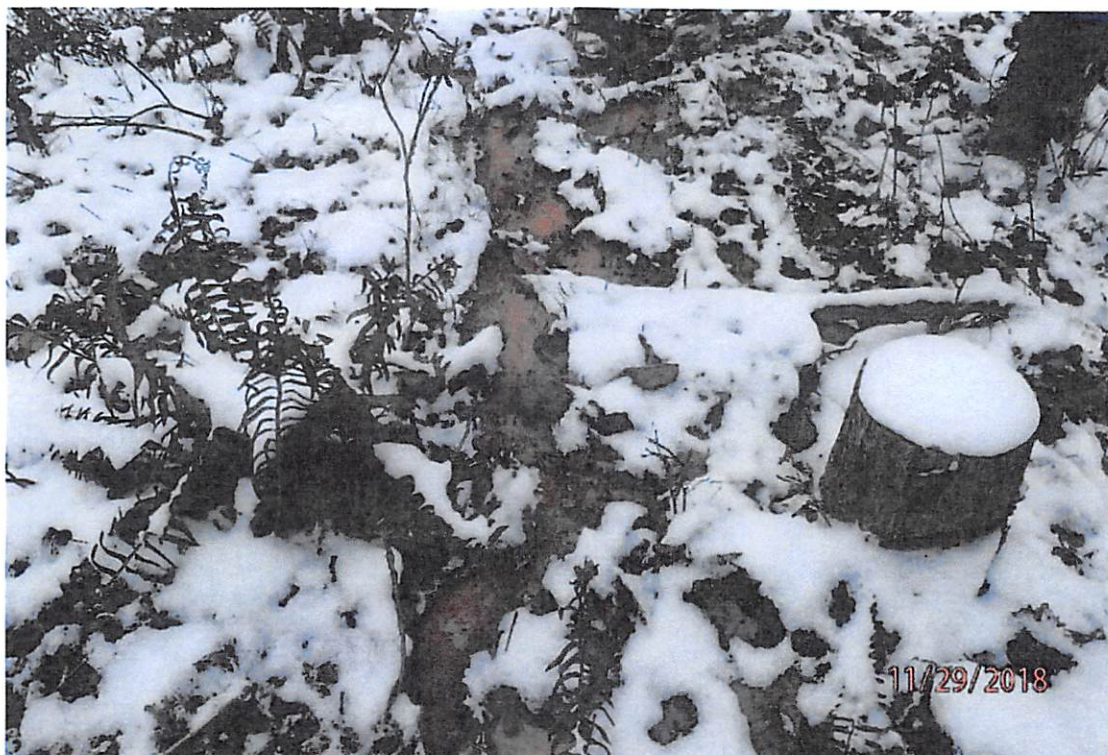
Offsite sediment laden water near 861+00 that originates from site due to a bypass at a water bar terminus BMP.

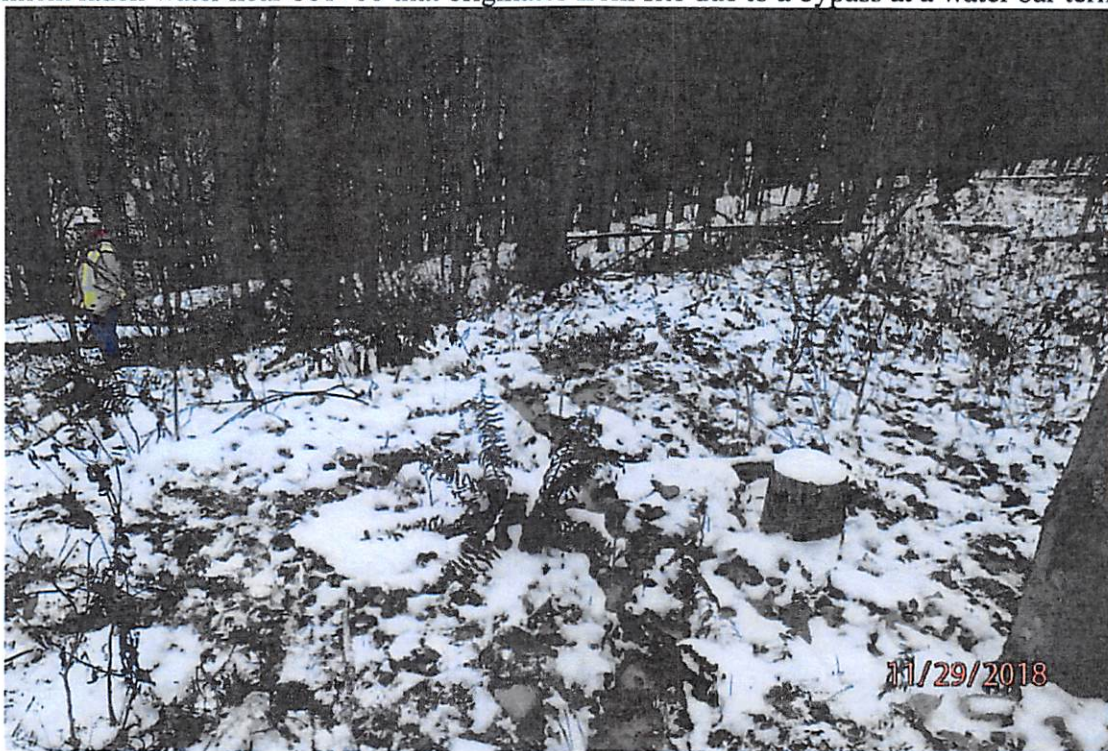
Offsite sediment laden water near 861+00 that originates from site due to a bypass at a water bar terminus BMP.

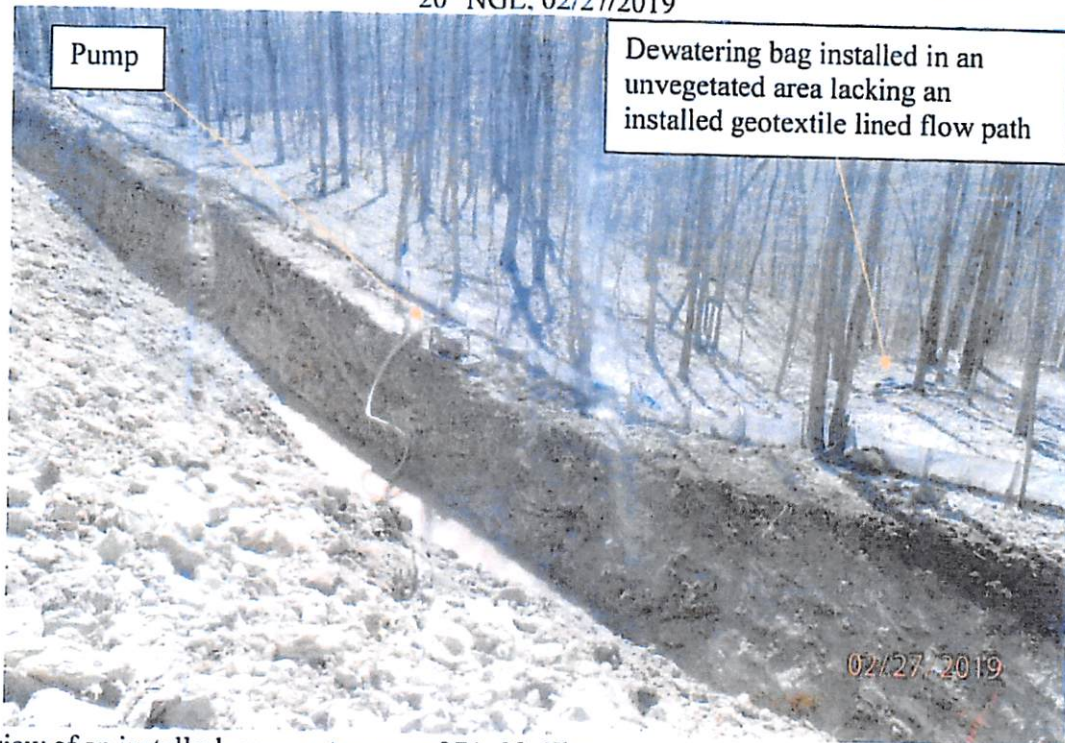
Overview of an installed pump set up near 374+00. The pump was not in use at the time of inspection.

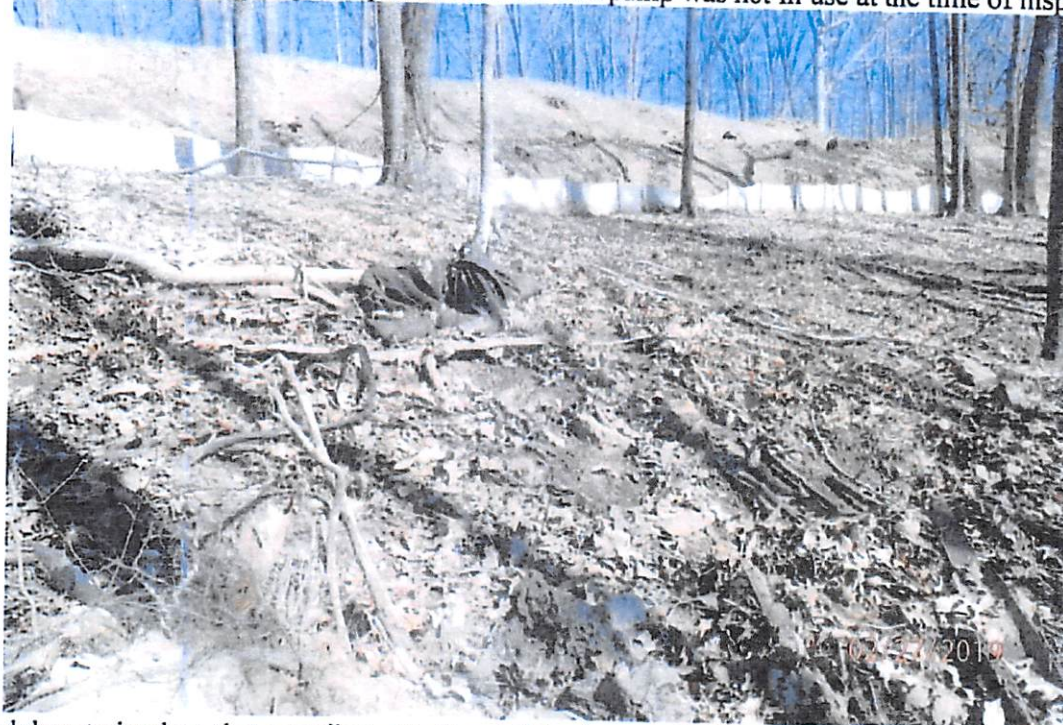
Installed dewatering bag that contributed to the visible plume in UNT Boggs Run showing the lack of an installed geotextile lined flow path and the associated erosion downslope of the device.

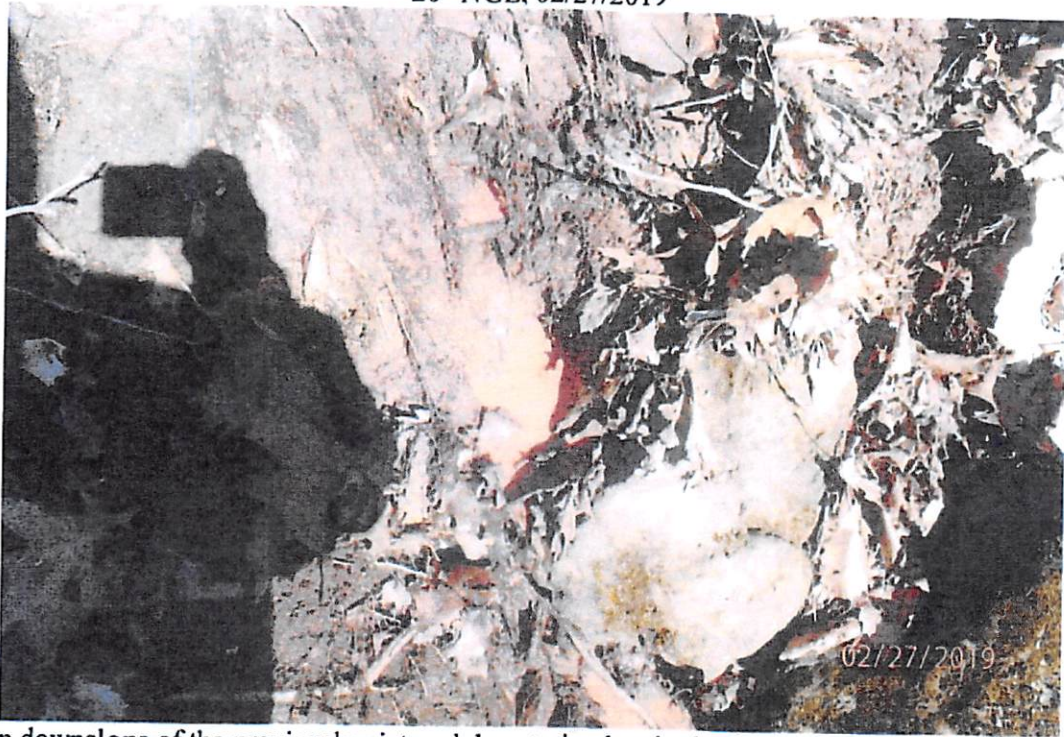
Erosion downslope of the previously pictured dewatering bag in the Boggs Run watershed showing the lack of an installed geotextile lined flow path and the associated erosion downslope of the device.

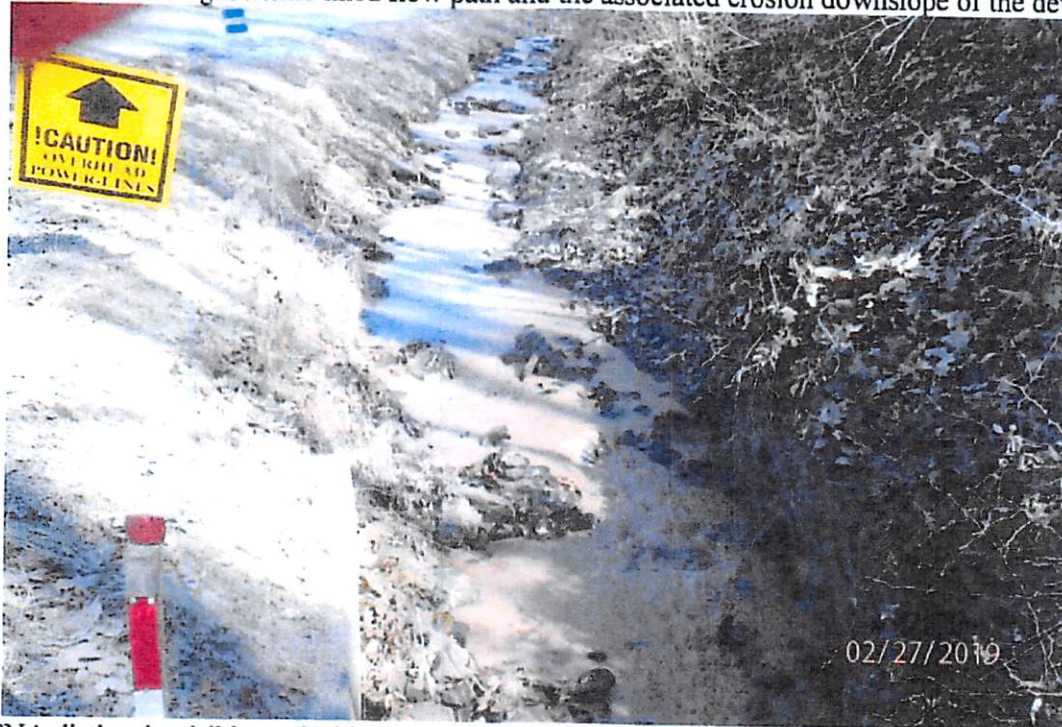
CNA distinctly visible settleable solids in Boggs Run as a result of the dewatering operation.

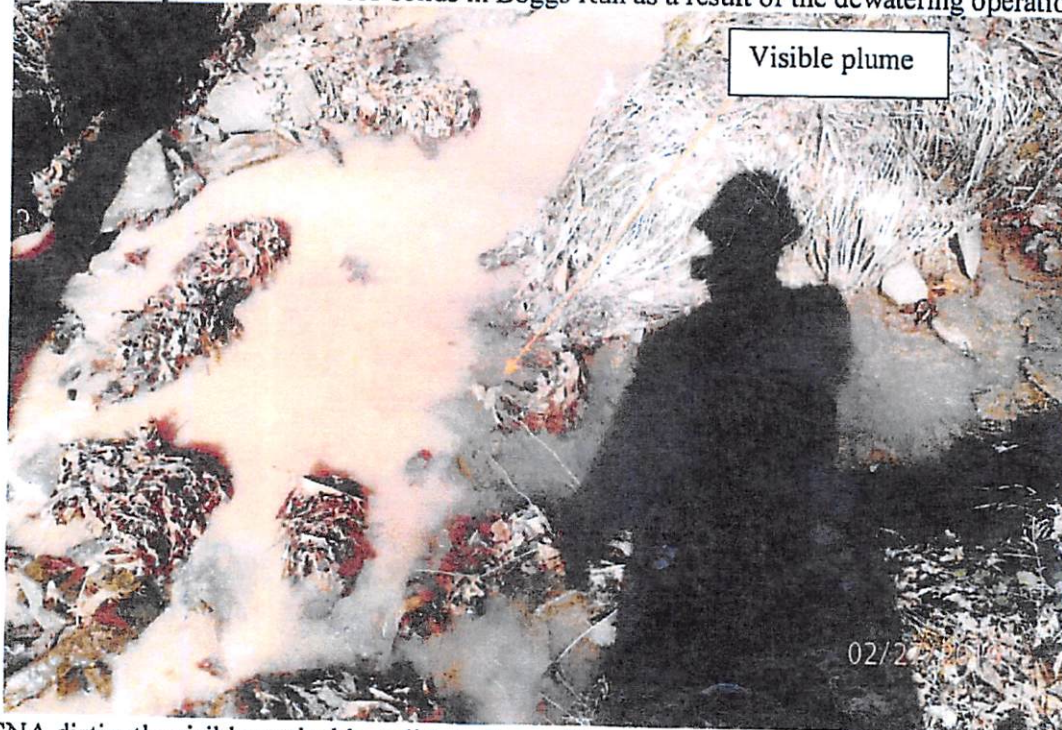
CNA distinctly visible settleable solids in Boggs Run as a result of the dewatering operation.

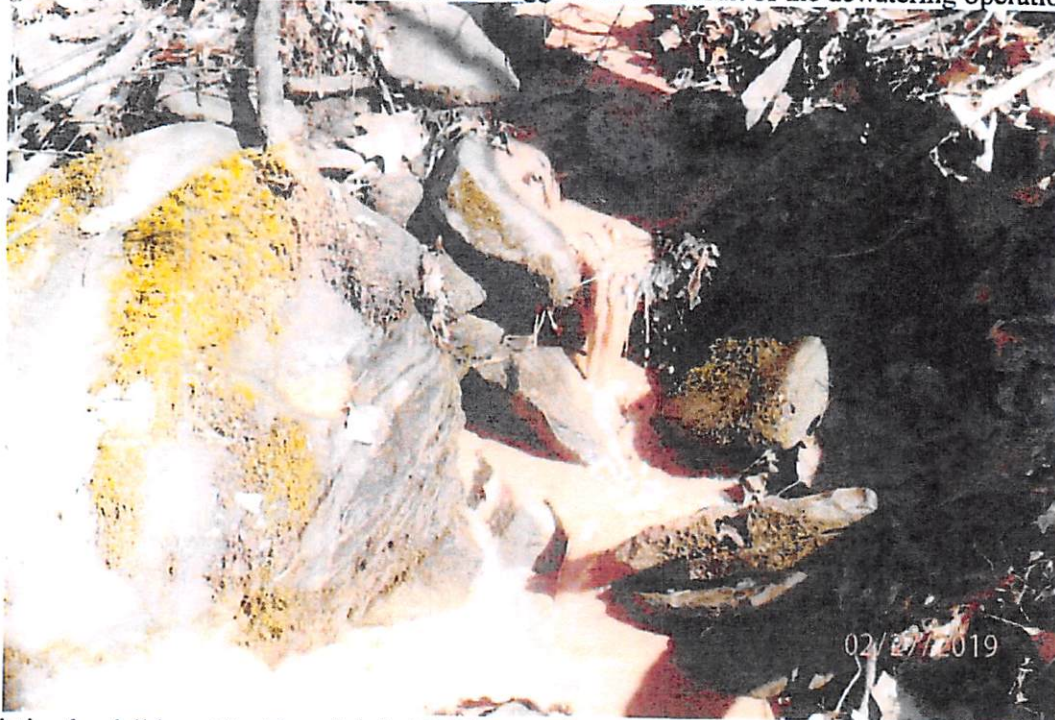
CNA distinctly visible settleable solids in UNT Boggs Run (UNT – 95) (39° 21.161' X 80° 39.549') as a result of the dewatering operation.
